Inventory and Reserve Study

Hollymead Community Association

November 10, 2006

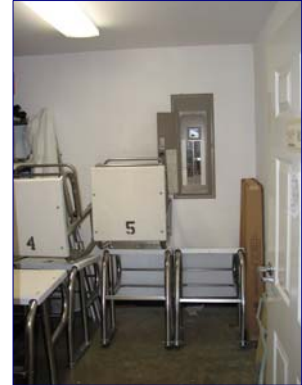
Problem: Violation of National Electrical Code, storage of equipment and materials in vicinity of main electrical panel.

Solution: Keep area clear in vicinity of this panel for safety and maintenance reasons.

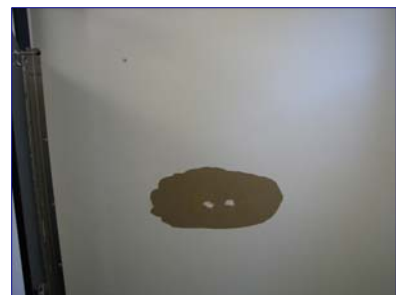
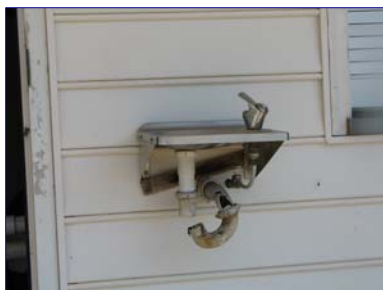
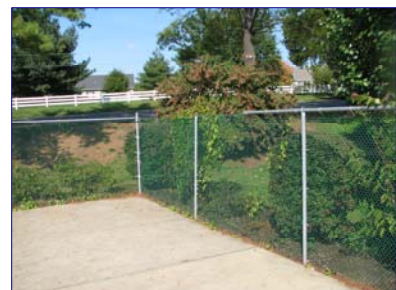
Problem: Pool chain link fence missing galvanized steel rail.

Problem: Drinking fountain drain pipe broken.

Solution: Repair fence rail.

Solution: Replace piping.

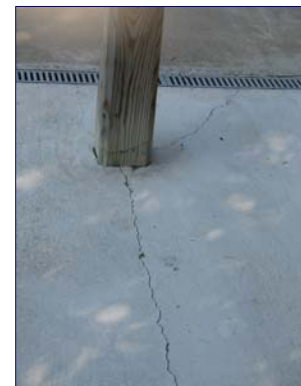
Both ceiling and floors were in good condition. Cracking is occurring due to a lack of expansion joints placed in the concrete slabs. This is not a critical item, rather a workmanship issue, at present.

Problem: Concrete slabs are cracking due to lack of expansion joints.

Solution: Cut concrete and install expansion joints and repair cracks.

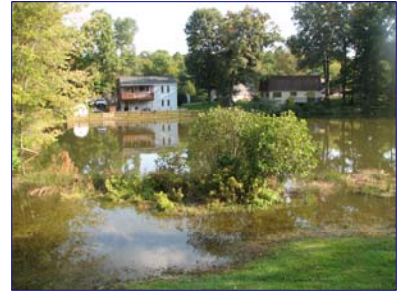
There is significant foliage, large trees and brush growing, on the downstream dam face. This should be removed as the roots have the possibility of weakening the dam creating early failure.

Problem: Bushes and large trees are growing on downstream side of the pond dam face. Roots from these large trees will eventually weaken the dam requiring major repairs or possible failure.

Solution: Remove trees and bushes. Replant dam face with grasses requiring low maintenance and bush hog 2-3 times yearly to prevent return growth of trees.

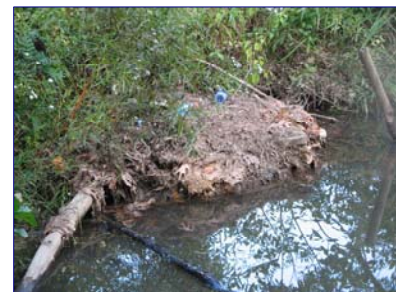
There is significant foliage, large trees and brush growing on the downstream dam face. This should be removed as the roots have the possibility of weakening the dam creating early failure. Also, there was a lot of plant growth right up to the edge of the pond. This will lead to erosion and loss of effectiveness of the pond and should be cleared for some distance back from the high water elevation.

Problem: Bushes and large trees are growing on downstream side of pond dam face. Roots from these large trees will eventually weaken the dam requiring major repairs or possible failure.

Solution: Remove trees and bushes. Replant dam face with grasses requiring low maintenance and bush hog 2-3 times yearly to prevent return growth of trees.

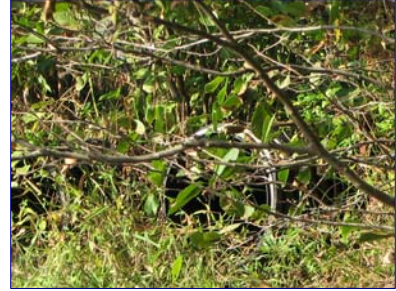
Problem: It appears that the overflow structure regularly clogs.

Problem: Bushes and trees may be growing around entrance to dam overflow piping.

Solution: Clean inlet and pipes and establish a regular cleaning schedule to prevent unnecessary use of emergency overflow, erosion and potential dam failure.

Solution: Clear brush and trees from piping. Maintain with regular cutting and grounds maintenance.

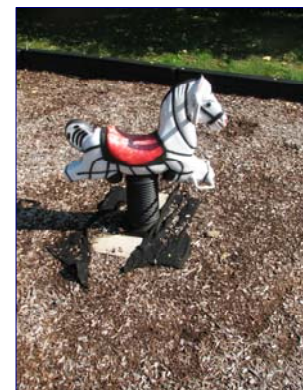
Problem: Rocking horse play implement requires rubber padding over concrete base.

Solution: Install rubber padding.
