Inventory and Reserve Study

Hollymead Community Association

November 10, 2006

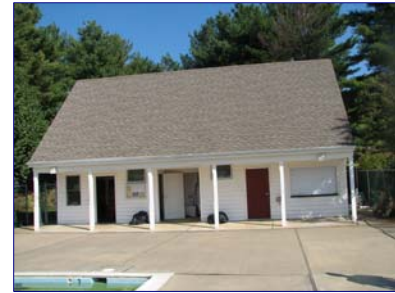
The pool house was constructed in 1996 and is 10 years old. The facility is in good shape although the vinyl siding is starting to show it's age. Maintenance requirements have been minimal with only power washing of the siding occurring on a semi regular basis. Windows and doors fit tightly and seals appear to be in good condition. Latches, locks and hardware are all functional. It is recommended that an IR camera be used to assess the facility for the presence of moisture and mold, just to insure the continued good condition of the facility.

The interior of the facility was showing some signs of wear and tear and is in need of paint and small repairs. These are noted in the deficiency section below. The pool equipment room pump trench is in need of a small sump pump to prevent the collection of standing water from pump repairs and minor leakage. Interior walls had some damage from equipment movement and door swings due to lack of door stops. Both ceiling and floors were in good condition.

Heating is by means electric base board heaters. This equipment requires cleaning and servicing to ensure continued functionality. The toilet areas each have an exhaust fan which were in operating condition, but also require cleaning. These later items are approaching the end of their useful life. Replacement of both fans is recommended upon failure of either system.

Water closets, urinals, lavatories and sinks all were in functioning and good condition. No leakage was noted on any item. The building hot water is supplied by a 10 gallon 1650W electric hot water heater. This unit is 10 years old and is probably due for replacement which is recommended upon failure.

Solution: Repair and paint drywall. Install door stops to prevent future damage.

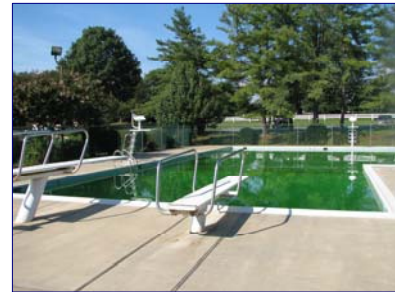
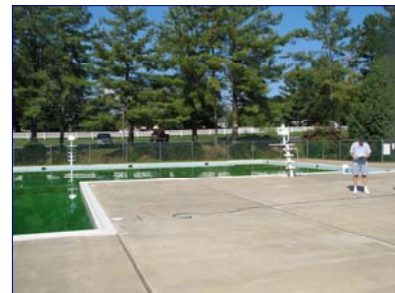
The pool was constructed in 1996 and is 10 years old. The facility is in good shape with no cracking, leakage or missing tiles noted. Pool concrete paving is in very good shape. The pool diving boards and lifeguard chairs need minor maintenance. The pool light poles also require painting. It was noted that the pool high rate filter is reported to be not functioning. It was also reported that the 10 HP pool circulation pump required replacement during the past year. These systems should be examined and repaired as may be necessary before the beginning of next summer's pool season.

Problem: Standing water in drainage swales and a clogged storm water inlet. Standing water and very moist soil conditions can lead to mosquitoes. With incidence of West Nile virus, this can be a health hazard as well as a nuisance to swimmers and other pool users.

Problem: Pool light poles are rusting and paint is chipping. This will eventually effect pole structural integrity as well as decrease life of steel poles.

Problem: Life Guard Chairs rusting at base

Problem: Diving board bases are showing rust.

Solution: Initiate contract with a pool company to troubleshoot and repair pool pump and associated equipment as necessary.

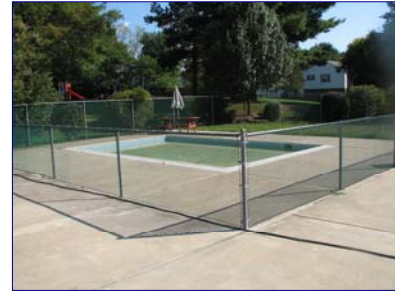
This pool was also constructed in 1996 and is 10 years old. The facility is in good shape with no cracking, leakage or missing tiles noted. Pool concrete paving is in very good shape. The fence surrounding the wading pool is in good repair.

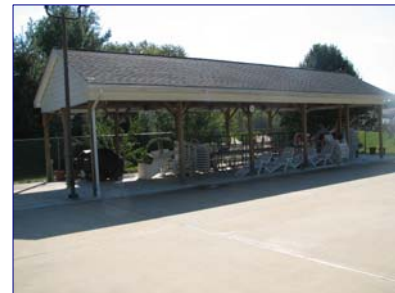
Both ceiling and floors were in good condition. Cracking is occurring due to a lack of expansion joints placed in the concrete slabs. This is not a critical item, rather a workmanship issue, at present.

Problem: Concrete slabs are cracking due to lack of expansion joints.

Solution: Cut concrete and install expansion joints and repair cracks.

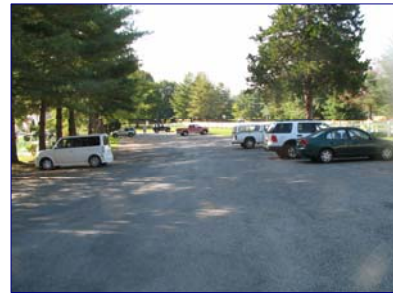
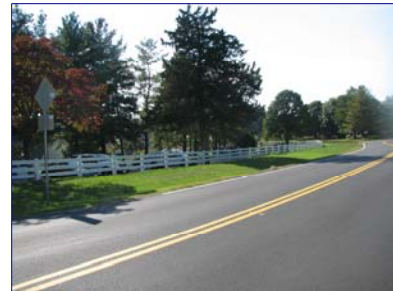
The fence and parking lot were constructed in 1980. The parking area appears to be at least partially covered with a layer of asphalt with gravel placed on top. The parking area is planned for resurfacing in 2010. The fence appears to have been painted regularly, the last time being in 2006.

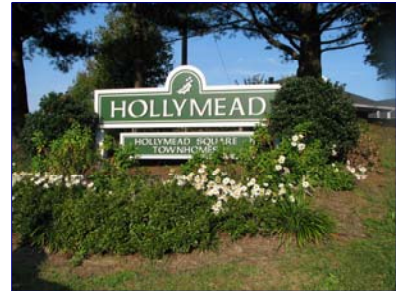
The sign was constructed in 1990. It is regularly maintained and in excellent condition. The spot lights and associated electrical wiring were replaced in 2005 and are in nearly new condition.

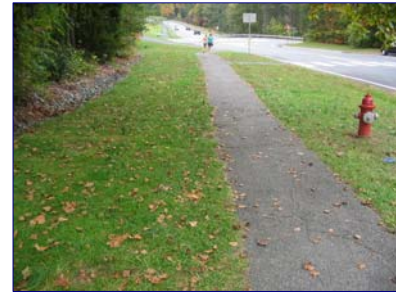
The paved pathways were constructed in 1990. Pathways are asphalt with the exception of those in the vicinity of the Hollymead School. Repairs, some expansion and resurfacing work were performed in 2005 bringing all walkways up to a very good condition.

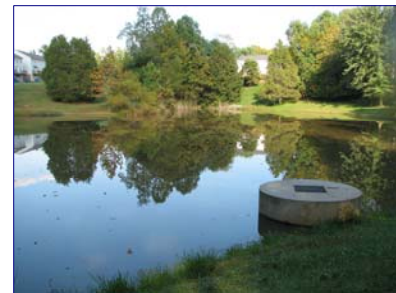
The storm water pond was constructed in 1980. It was dredged in 2003 (approximate reported cost \$60,000) and is reported to be approximately 16' in depth at the base of the dam (deepest point). It was reported to have been silted to a depth of about 6' before it was cleaned out. Based on reported truck loads and cost, we have calculated an average silt depth of 3.0' over the 1.0 acre surface area of the pond.

There is a concrete outlet structure approximately 8' in diameter and an emergency overflow channel. No clogging of significance was noted after recent extremely heavy rains.

There is significant foliage, large trees and brush, growing on the downstream dam face. This should be removed as the roots have the possibility of weakening the dam creating early failure.

Problem: Bushes and large trees are growing on downstream side of pond dam face. Roots from these large trees will eventually weaken dam requiring major repairs or possible failure.

Solution: Clean inlet and pipes and establish a regular cleaning schedule to prevent unnecessary use of emergency overflow, erosion and potential dam failure.

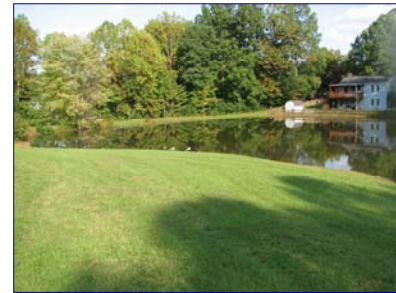
Site and Utilities

There is significant foliage, large trees and brush growing, on the downstream dam face. This should be removed as the roots have the possibility of weakening the dam creating early failure.

Problem: Bushes and large trees are growing on downstream side of the pond dam face. Roots from these large trees will eventually weaken the dam requiring major repairs or possible failure.

It is recommended that the HCA 1) remove accumulated debris and vegetation growing in the ponds, 2) survey the pond to establish a current profile of the bottom of the pond. This should be performed on a five year interval so that a local sedimentation rate is established and thus, a required frequency for dredging determined. Finally, to ensure minimal problems in dredge disposal, it is recommended that the sediment be periodically sample for the presence of common contaminants.

Solution: Clean inlet and pipes and establish a regular cleaning schedule to prevent unnecessary use of emergency overflow, erosion and potential dam failure.

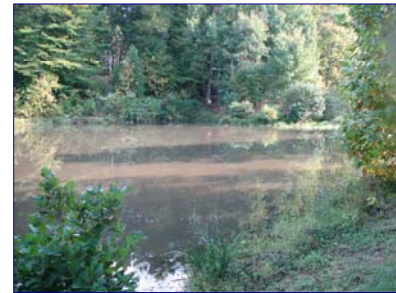
The storm water pond was constructed in 1980. It has not been dredged since initial construction. It is reported to have a depth of approximately 10' at the base of the dam. Current water depth is estimated at 3' and the pond is in need of dredging.

There is significant foliage, large trees and brush growing on the downstream dam face. This should be removed as the roots have the possibility of weakening the dam creating early failure. Also, there was a lot of plant growth right up to the edge of the pond. This will lead to erosion and loss of effectiveness of the pond and should be cleared for some distance back from the high water elevation.

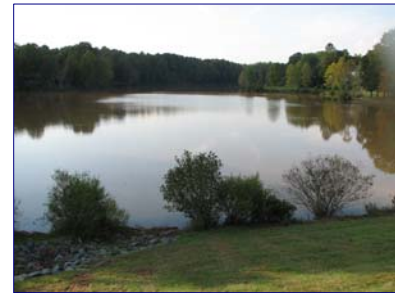
Lake Hollymead was constructed in 1980. It has not been dredged since initial construction and it is reported to be only 3'-4' in depth due to sedimentation. Estimated original depth of the lake is 50' at the base of the dam. This would indicate a real sedimentation problem that needs to be addressed soon.

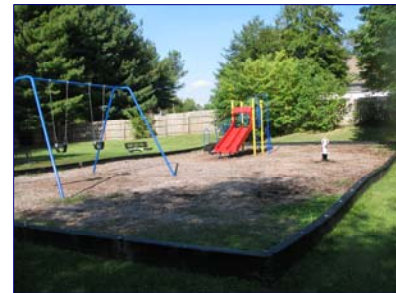
The playground was constructed in 2001. The playground fence was constructed in 1980 with portions of it being replaced in 2004. The playground equipment appeared to be in good repair with the protective surface of wood chips. The plastic retaining border also appeared to be in good condition.
